# VISTA PARK

COMPARISON OF OWNER'S FLORIDA DEPARTMENT OF ENVIRONMENTAL PROTECTION (FDEP) APPROVED VOLUNTARY CLEANUP ORDER (VCO) APPROACH AND CORPS OF ENGINEER'S (COE) APPROACH TO CLEARANCE OF THE VISTA PARK PROPERTY.

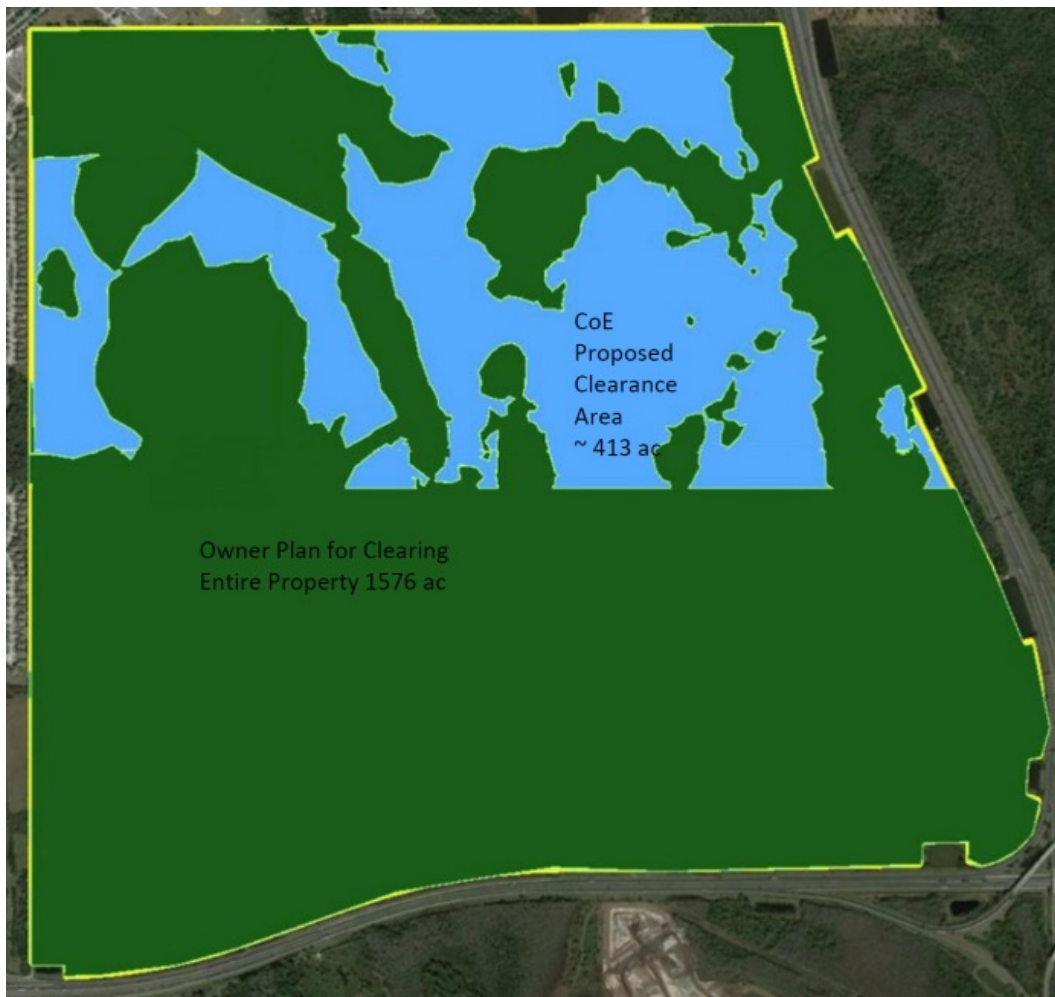
Figure 1 - Extent of Clearance Voluntary Cleanup Order vs CoE

- The CoE approach (see the blue shaded area in Figure 1) only addresses up to 413 acres excluding the southern half of the property; wetlands; existing roads; parking areas; under structures and within ponds. The Owner's VCO approach addresses the entire property of 1,576 acres.

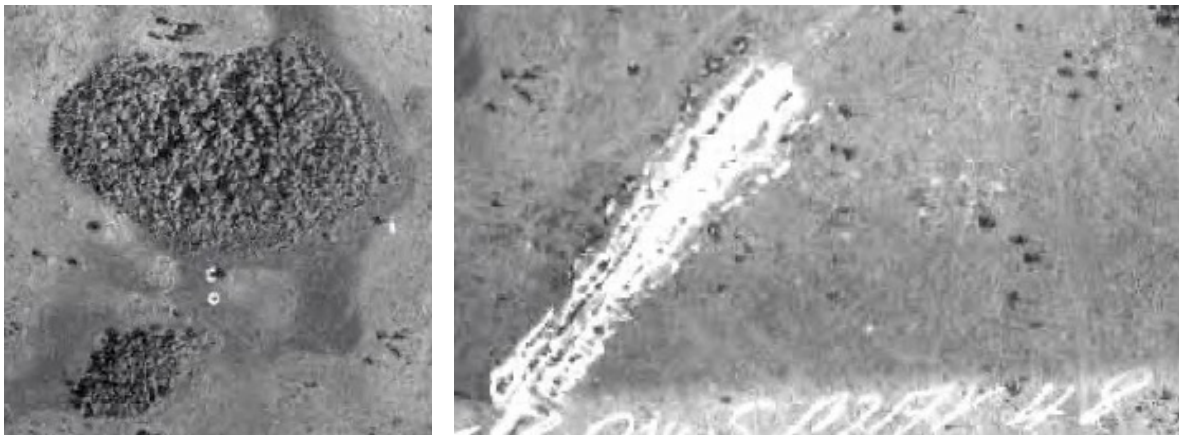
Figure 2 - Bomb craters in the southern part of the property from 1947 aerial

- The CoE approach has declared that there is no risk of UXO in the southern part of the property even though their own documentation shows bomb impact craters in historical aerial photos (1947) and their field investigation (2008/2009) recovered Munitions Debris from expended military munitions. The CoE contractor field records only document these items as "Munitions Debris Non Specific" and "Munitions Debris Frag". The identification of Munitions Debris fragmentation strongly indicates that high explosives munitions were utilized in this part of the property as the fragmentation is usually the result of high explosive detonation. It is probable that malfunctioned unexploded munitions items are also present in the vicinity. The Probable Bomb Impact Analysis carried out by the St Louis District of the CoE in 2007 identified target #6 Airstrip Target as being in the southern part of the property. The finding of no risk is onrtrary to the documented evidence.

- There is no question that high explosive general-purpose bombs were utilized on this property. This conclusion comes from detailed documentation in the CoE Archives Search Report, from contemporary photos of bombs impacting on the property and from the presence of a series of 20-foot wide high explosive bomb craters less than 500 feet from the boundary of the CoE nominated search area. Figure 2 above clearly shows bomb impact craters in the southern part of the property that are not addressed. The Owner's VCO approach addresses the potential for the presence of bombs in all parts of the property; the CoE approach does not.
